SHIPS LOUNGE BURNOUT EXPERIMENTS

R. C. RICHARDS AND A. DATTA

U. S. Coast Guard Research and Development Center
Avery Point Groton, Connecticut 06340

FINAL REPORT

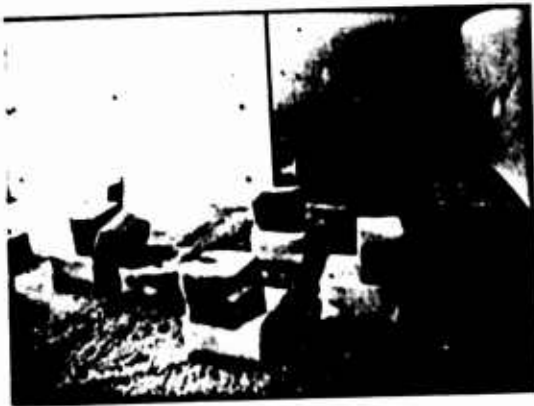
FIGURE 7. Pictures of 1/4-Scale Setup

Each lounge was furnished with the following items (see figure 7):
